**LEESBURG BOARD OF ARCHITECTURAL REVIEW
STAFF REPORT**

**WORK SESSION: 3 DECEMBER 2012
AGENDA ITEM 4A**

BAR Case No. THLP-2012-0127: Modifications to existing building at 6 W. Market St. differing from approved Certificate of Appropriateness TLHP-2012-0039.

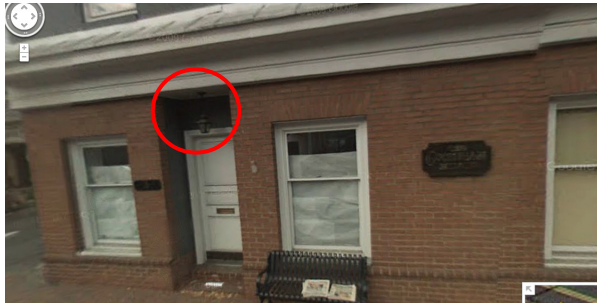
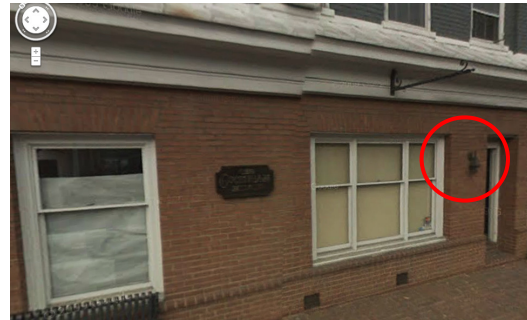
Below are photos of the front façade of 6 W. market Street showing the previously existing lighting fixtures which have been replaced and a third fixture added. This was under item (2) in the previous report:

- (2) The owner has installed lighting fixtures on the front elevation without approval

However, the placement of a third lighting fixture on the building between windows and where no doorway is located is not historically accurate and unless needed for safety should be removed. The two lighting fixtures by the doorways are appropriate in size and scale, while the center fixture is too large to be fixed to a building of this size and scale this close to the street.

1. The large light fixture be removed
2. The door surround is removed and the pediment is replaced with a smaller pediment that is only above the door as is shown in the applicant's most recent drawing and siding is to be patched where it was removed for this door surround
3. Brick matching the front elevation may be used on the side elevation no higher than twelve inches above the sidewalk or the bottom two rows of wood siding may be replaced with closely matching fiber cement siding painted to match the existing siding.
4. A dark traditional color of green, brown or blue is chosen for the main body of the building that is compatible with the unpainted brick
5. A contrasting traditional trim color is chosen that is compatible with both the new main body color and the existing unpainted brick
